Manhole Inspection Summary

Manhole # S33QQ_041MH

Location Address: **2634 CHARLES ST**

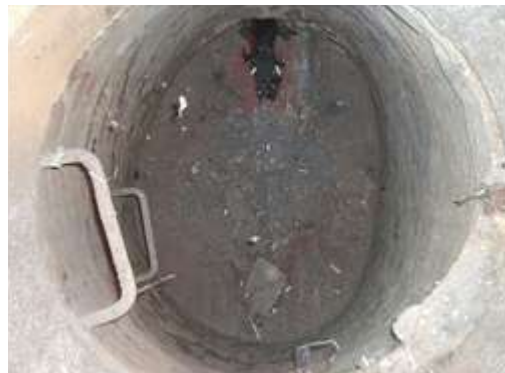
Top View

Channel debris.

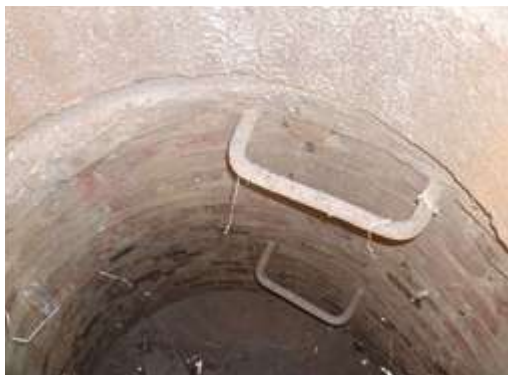
Defect

Frame leaks. Frame offset. Adjustment deterioration and infiltration. Barrel infiltration - other side.

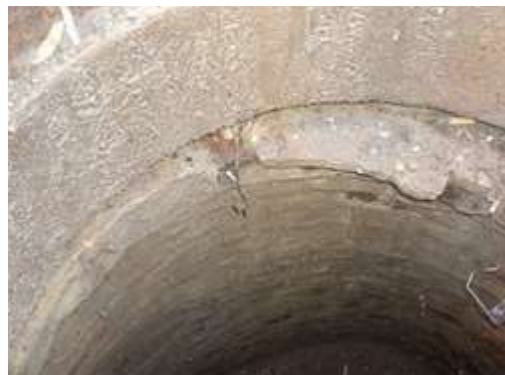
Defect

Frame leaks. Frame offset. Adjustment deterioration and infiltration. Barrel infiltration.

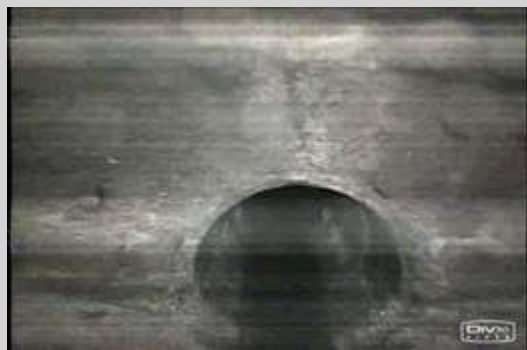
Pipe Out @ 12 O'Clock

8 in. Circular Gravity Sewer
